**ENGINEER'S REPORT**  
**of the**  
**MCCOY INCIDENT**

Jeffrey M. Kobilka, P.E., CFEI

November 4, 2021

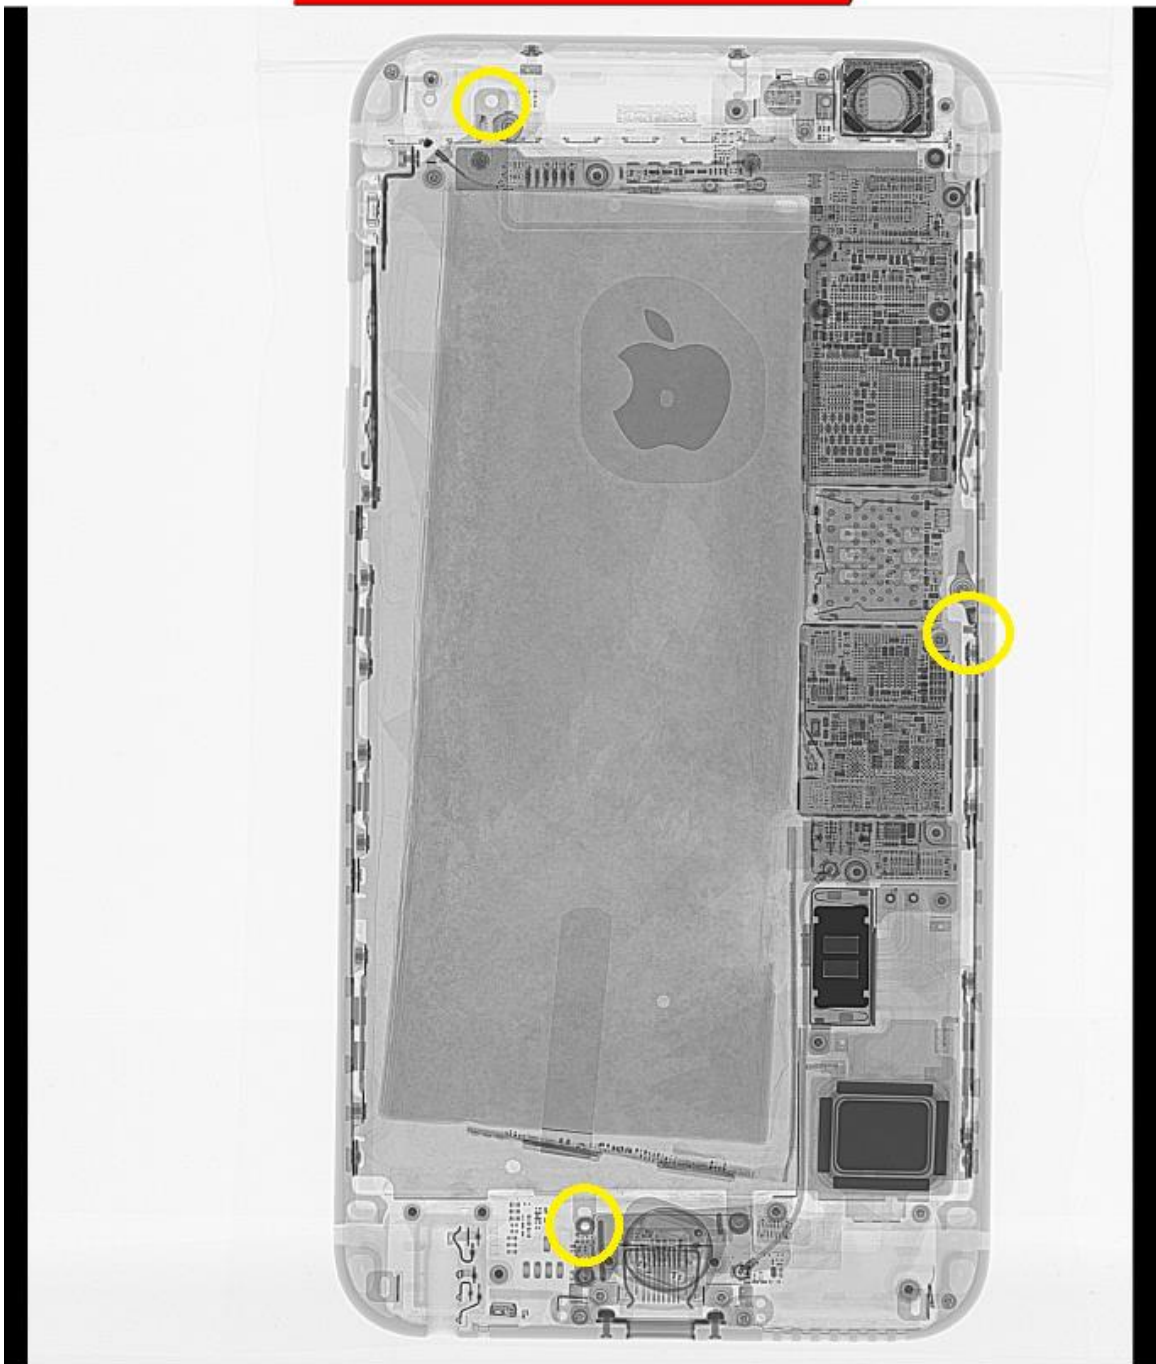
Figure 1- Missing screws and loose screw circled in yellow.

The photographs and radiography provided by SEL (Apple document production) demonstrate that there were multiple internal screws missing from the incident phone. The following screws were not installed in the remains of the phone: (2) mid-plate attachment screws, (3) screen assembly screws, and (1) side button bracket screw. Evidence examination confirmed these screws were not found installed in the appropriate locations. There was a screw found loose on the side of the phone containing the electronics, near the SIM card slot. This screw or one of the other missing screws was the object that penetrated the battery cell causing short circuit and thermal runaway.

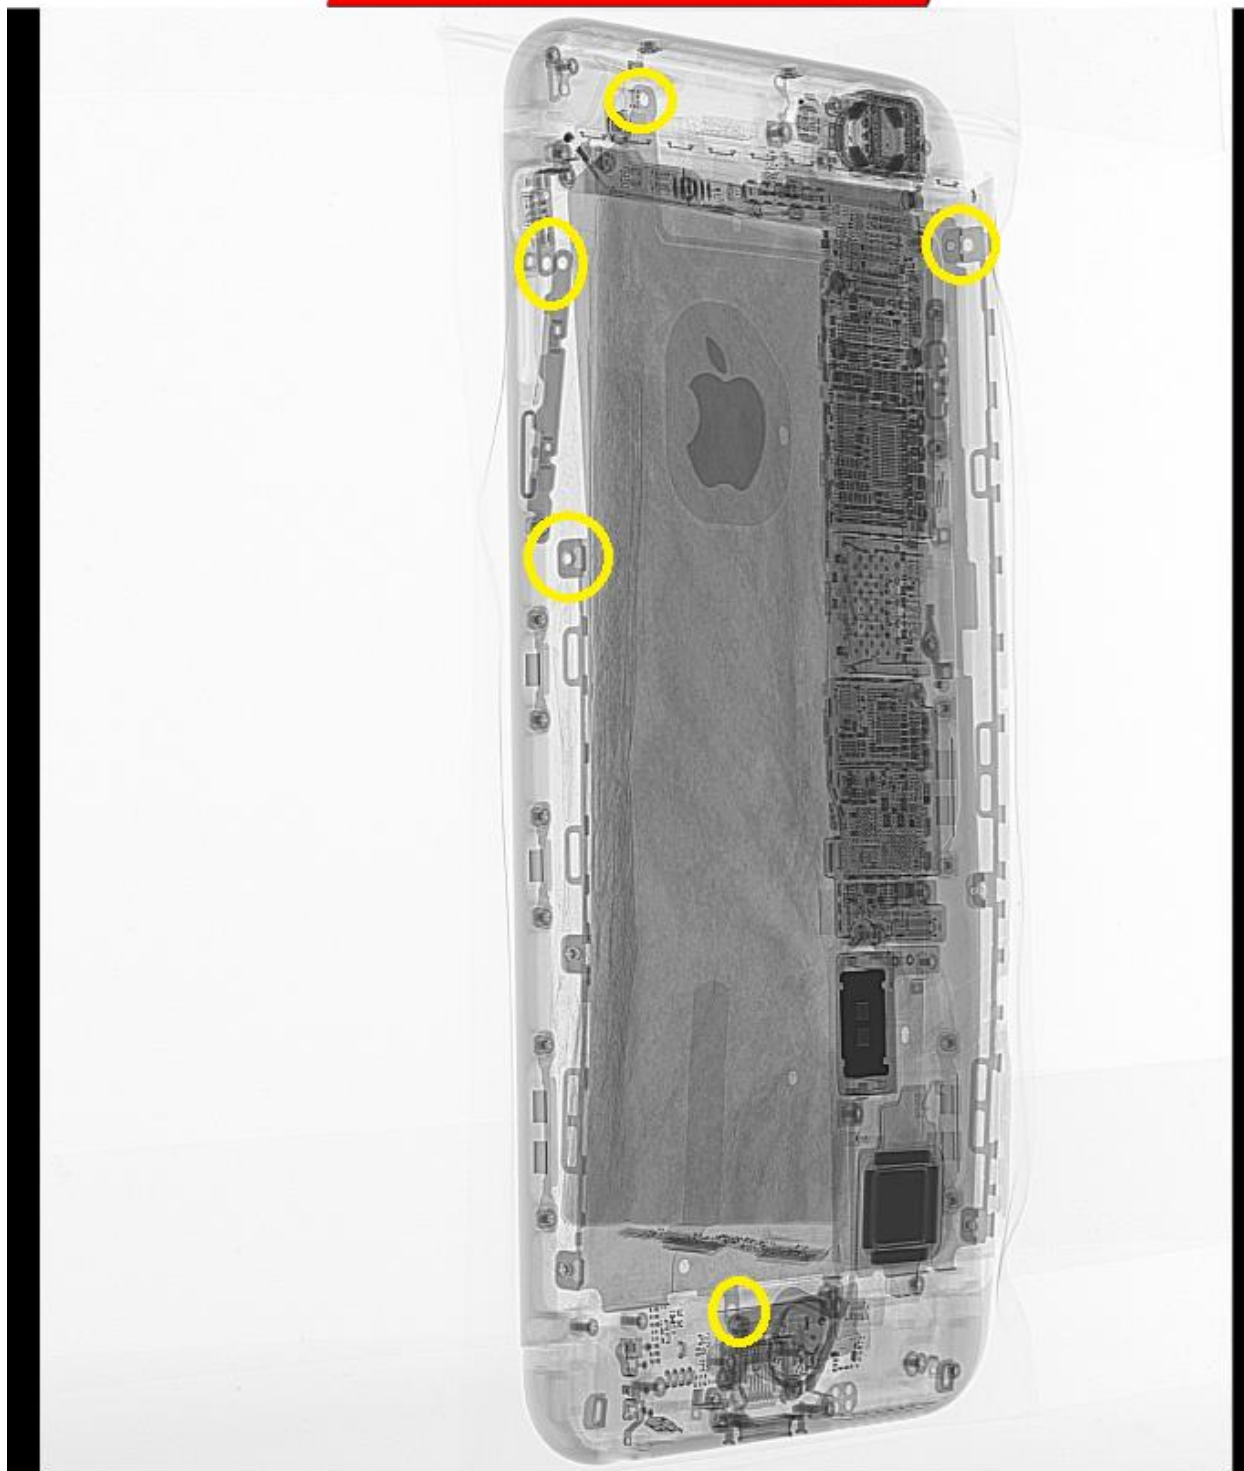
Figure 2 - Missing Screws circled in yellow

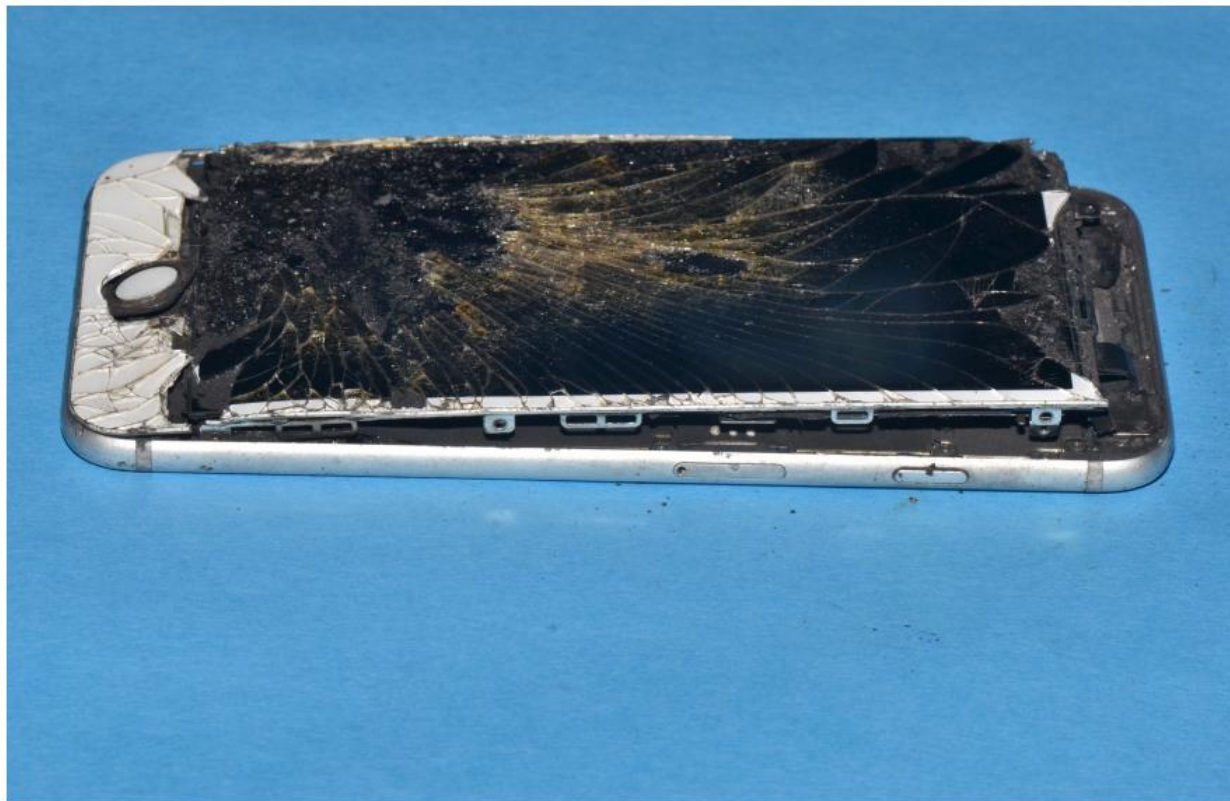
**Figure 3 - Damage from internal pressure and heat, missing screws**

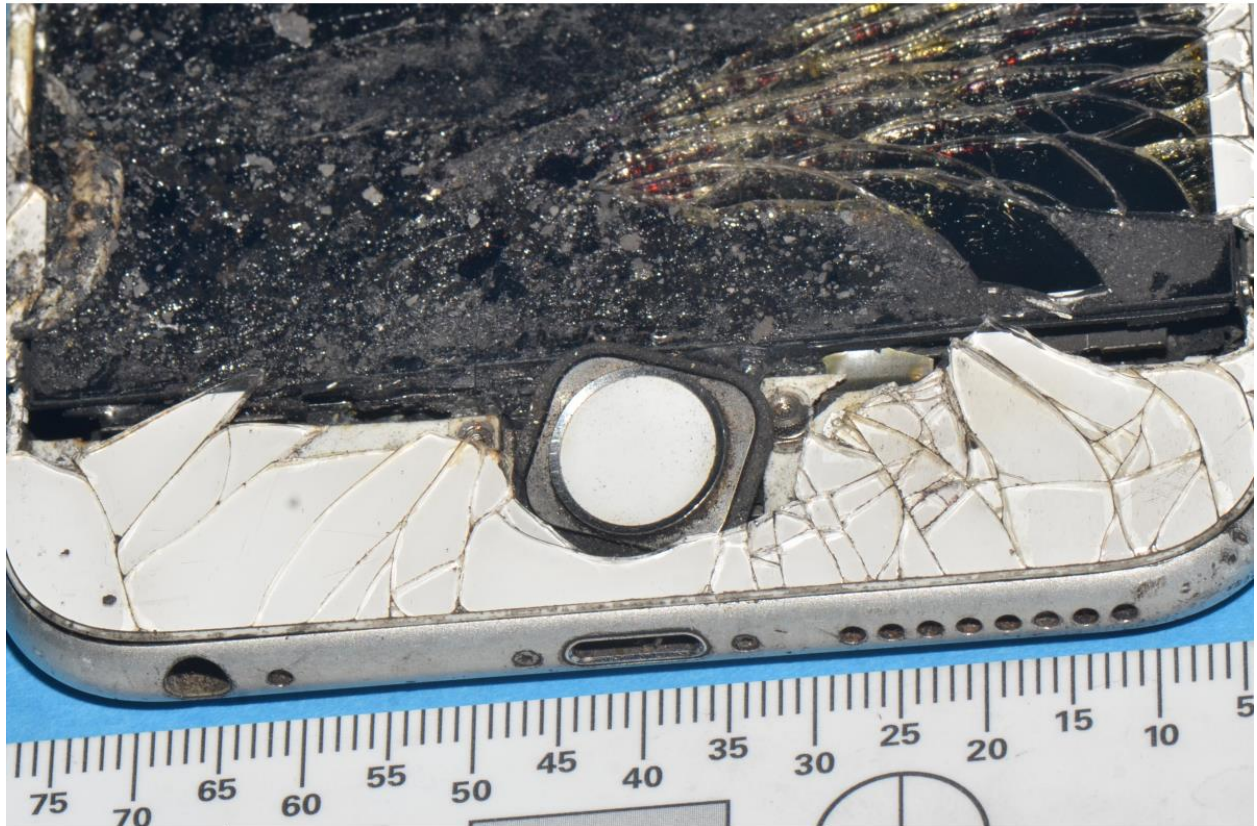
Figure 4 - Significant damage near lower half of the screen

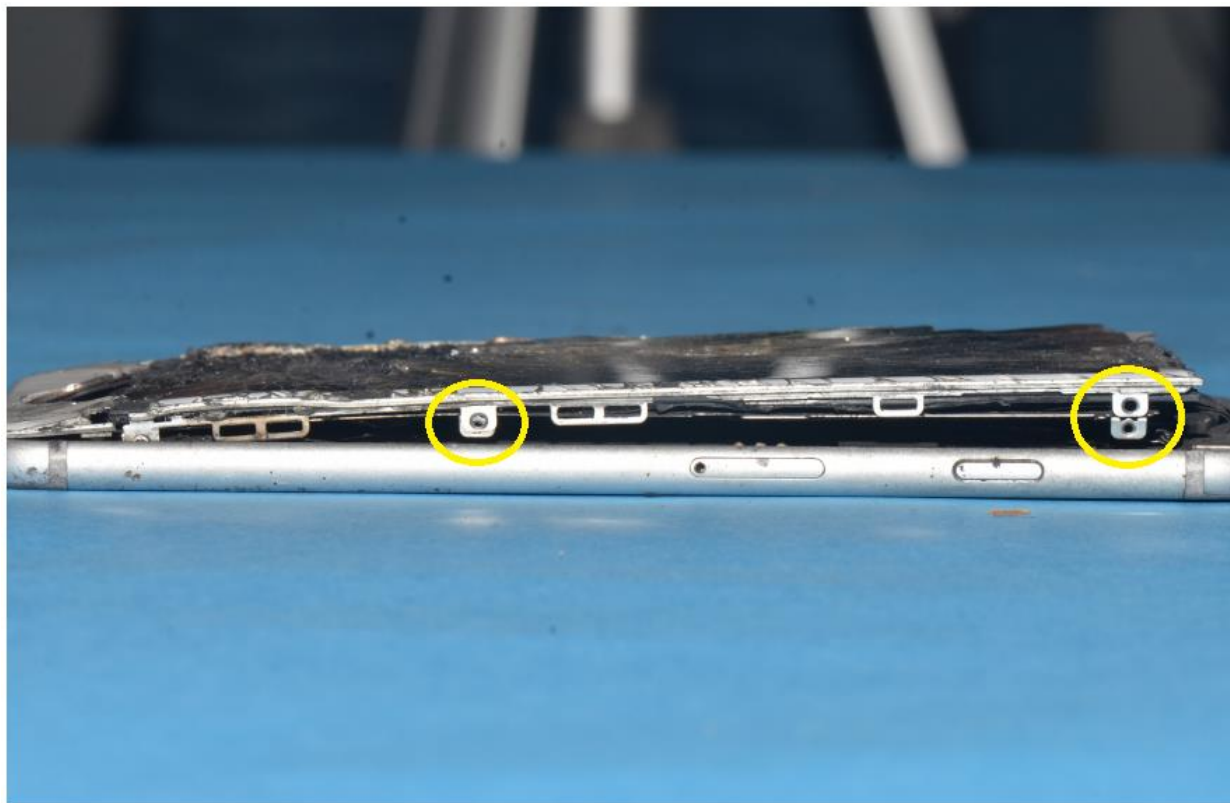
**Figure 5 - Missing screws, screen pushed upward from battery cell expansion**

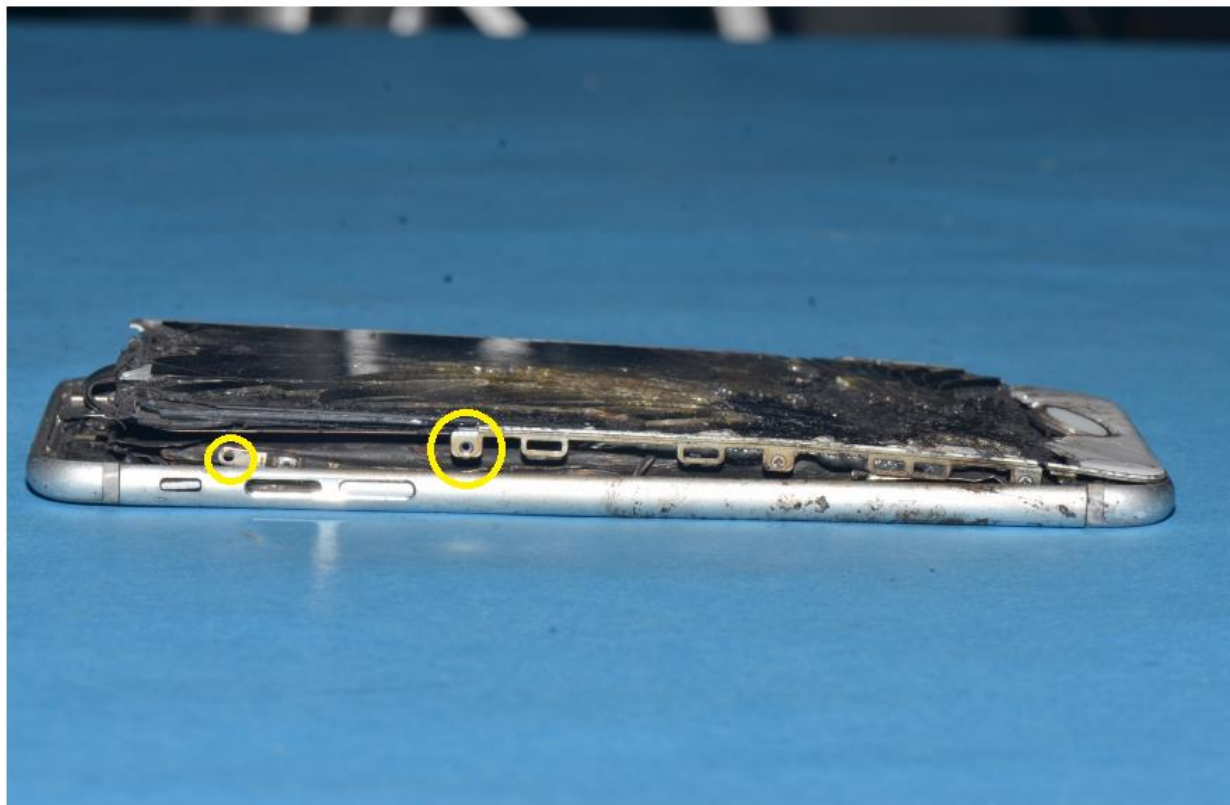
**Figure 6 - Missing screws, screen pushed upward from battery cell expansion**

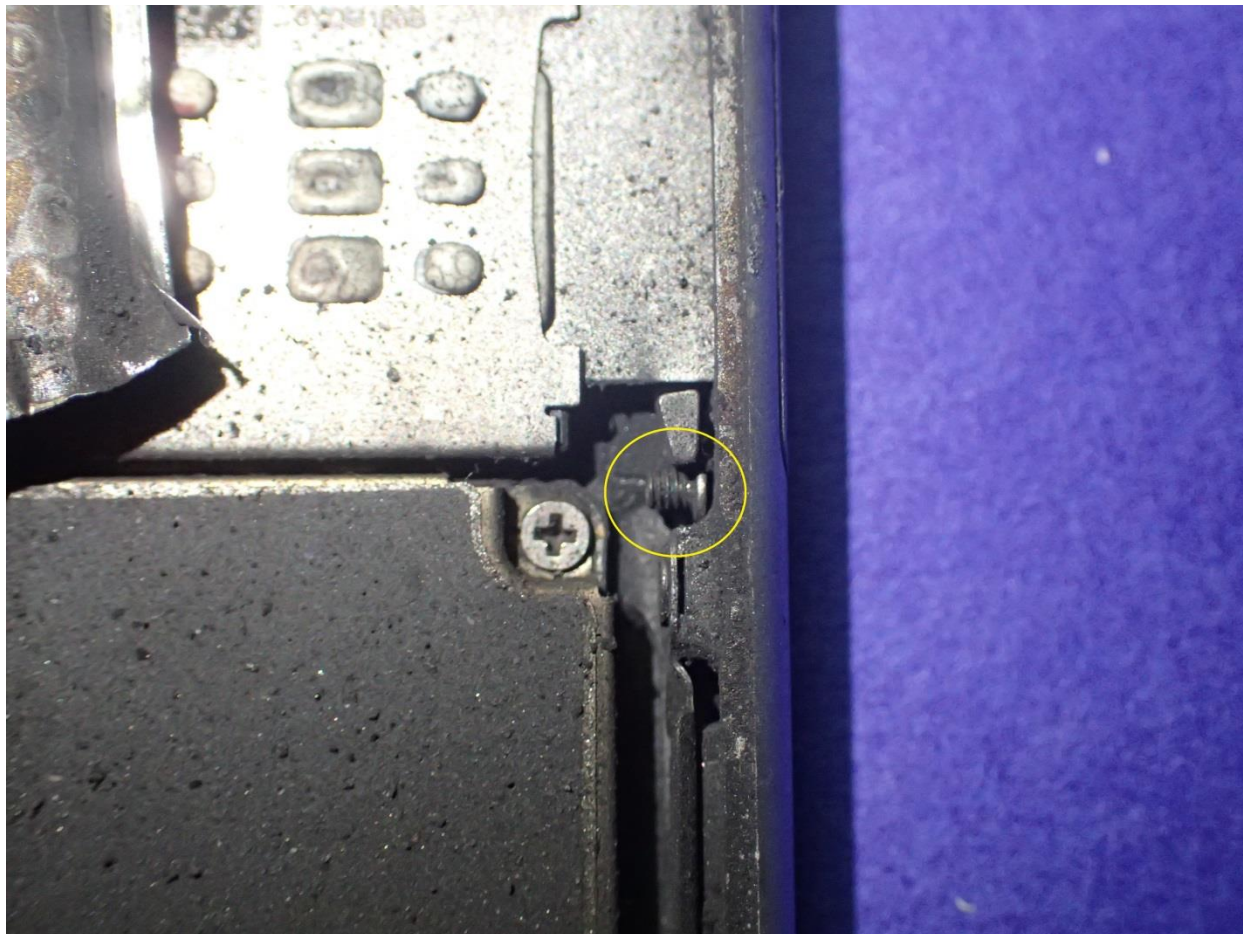
**Figure 8 - Loose screw inside incident phone**

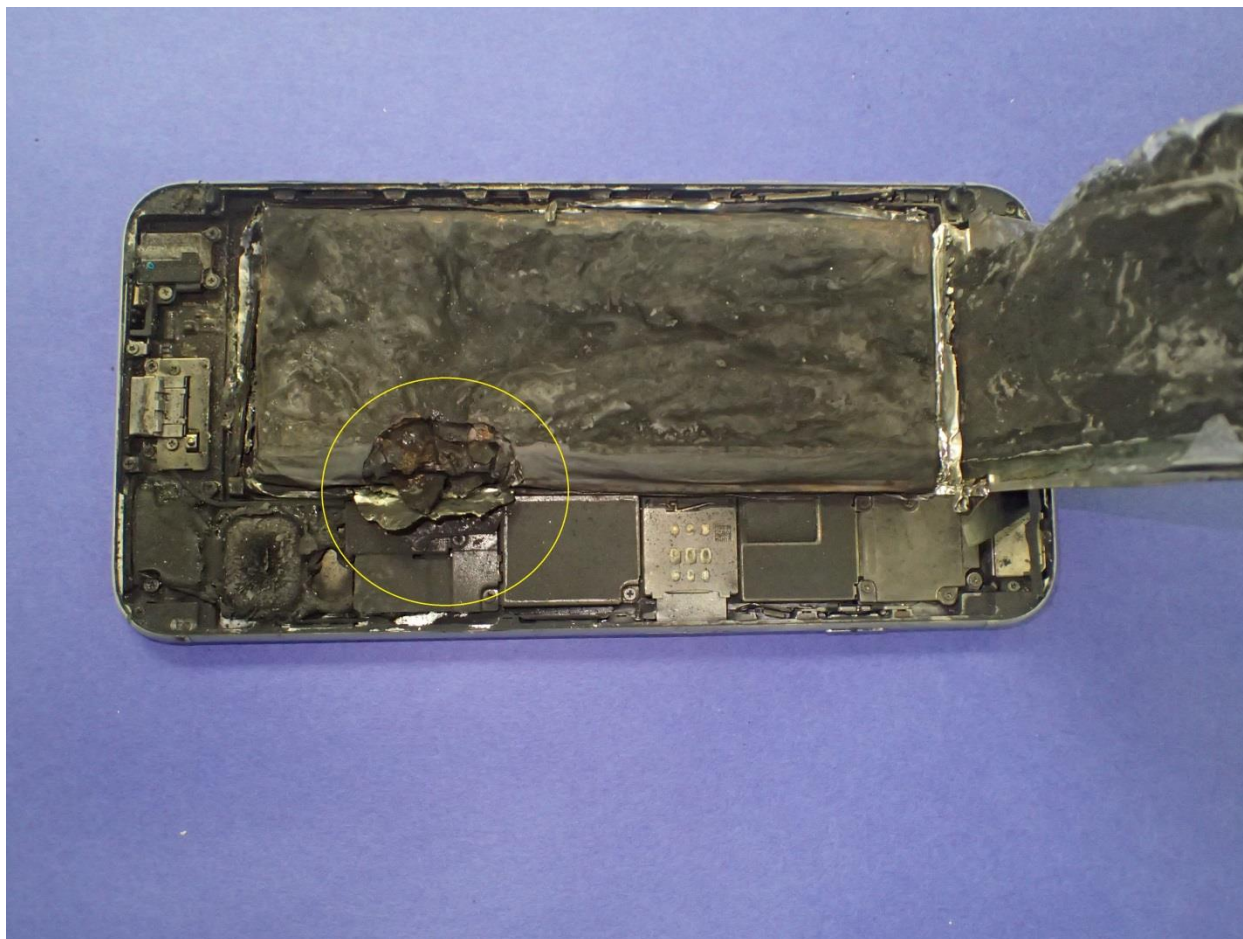
Figure 9 - Incident phone battery cell side rupture

The remains of the incident battery were examined. The remains demonstrate that the casing of the battery was torn open and internal components were expelled (Figures 9, 13). The heat and force placed on the phone by the expanding battery cell caused the screen to crack separate from the case. The cause of the explosion is thermal runaway within the incident battery cell.

The loss of battery cell material observed via radiography is most significant on the screen-facing side towards the internal electronics. This area is shown in figures 9 and 13. There is evidence of high heat on the mid plate, which is between the battery and the screen. The mid plate demonstrates a hole. While this part of the phone experienced high heat, the hole was not caused by the thermal runaway or external damage. The hole on the mid-plate is a part of the manufacturer’s design. The damage pattern visible on the exterior of the screen is consistent with the battery cell rupture location, again indicating damage from an internal source. The rupture on the side of the battery is consistent with an object penetrating the battery cell casing.

The sample battery cells for the iPhone 6 passed this section of the requirements. The damage observed on the battery cell is not indicative of the actuation of a pressure relief mechanism instead it is consistent with an object penetrating the battery cell casing causing internal short circuit, thermal runaway, and cell rupture.

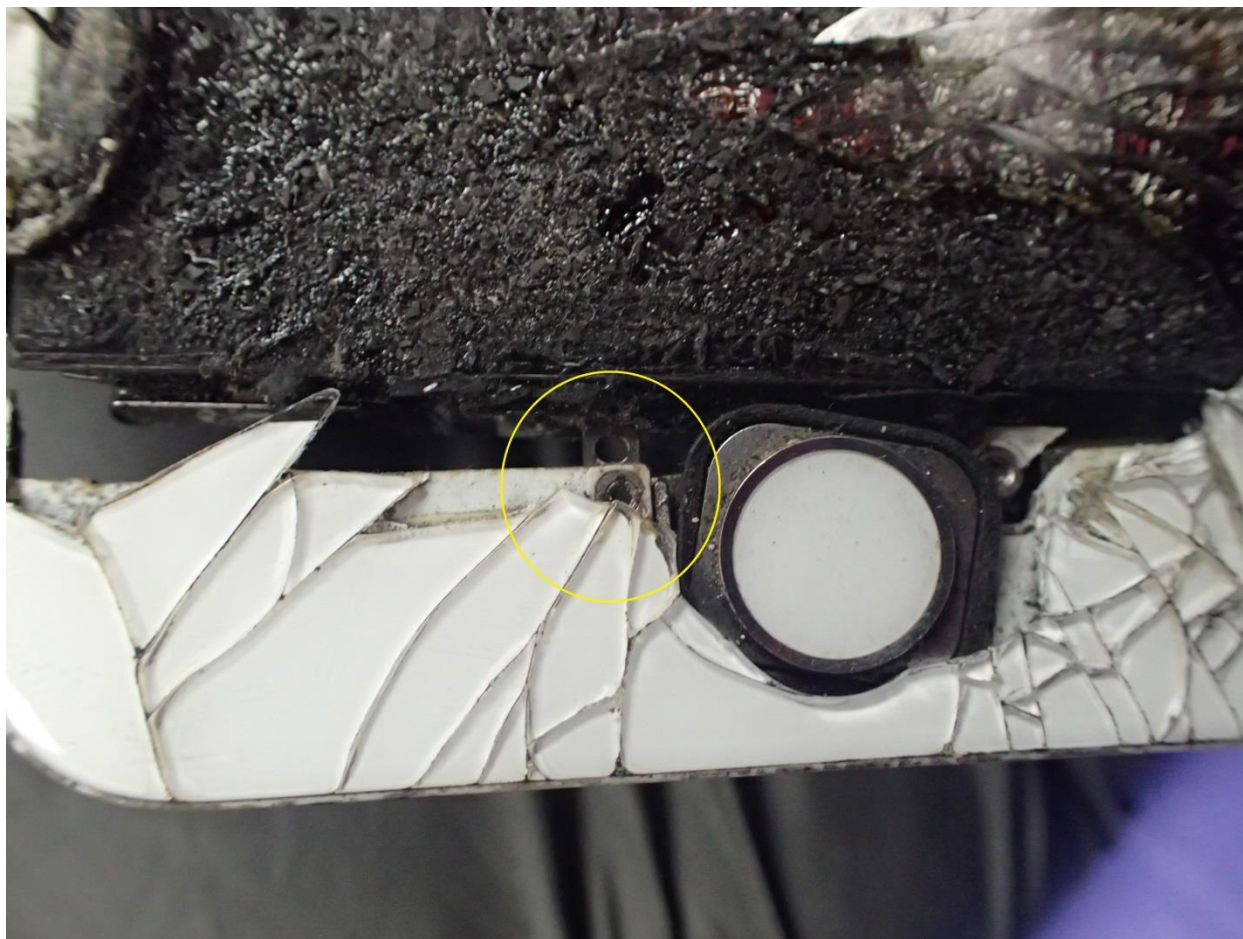
Figure 10 - Missing screw near home button

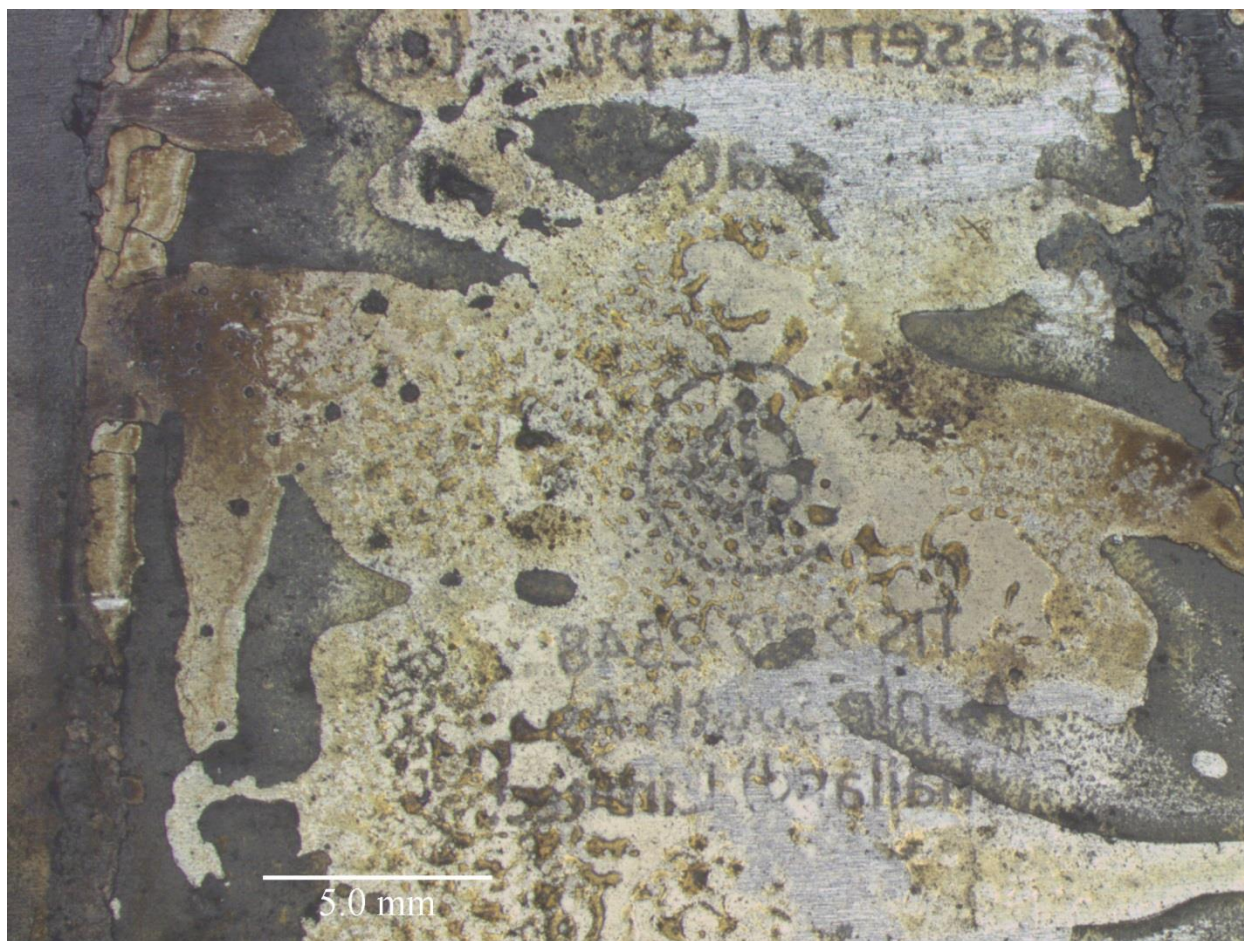
Figure 11 - Battery Label transferred to mid-plate - "Apple South Asia"

The high heat of the battery caused the label of the battery to be partially transferred to the mid plate. The visible sections of the transferred label are consistent with an Apple manufactured battery cell. Apple has sample battery cells tested by an external testing organization for compliance with IEC 62133. This standard has requirements concerning venting:

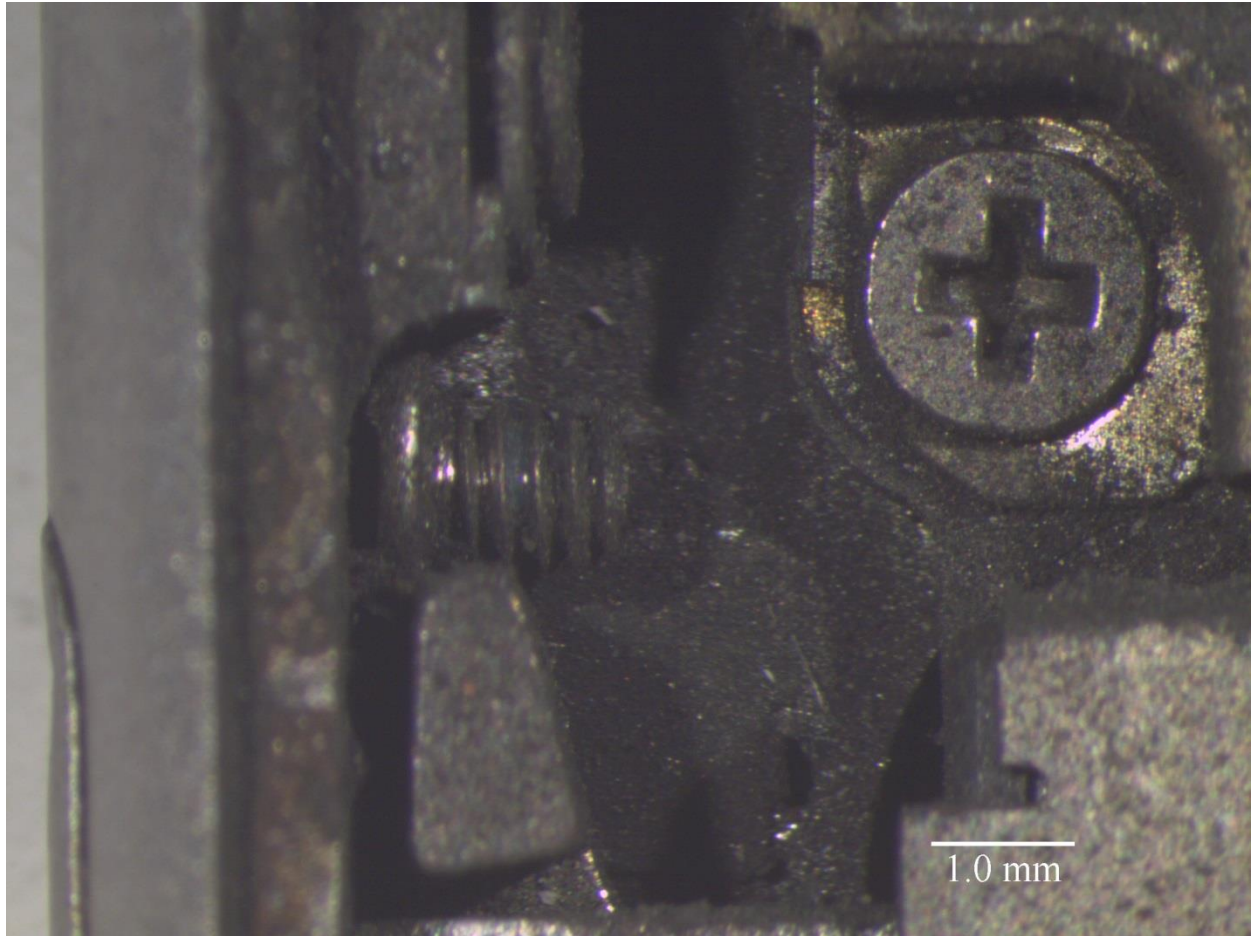
Figure 12 - Close up of loose screw

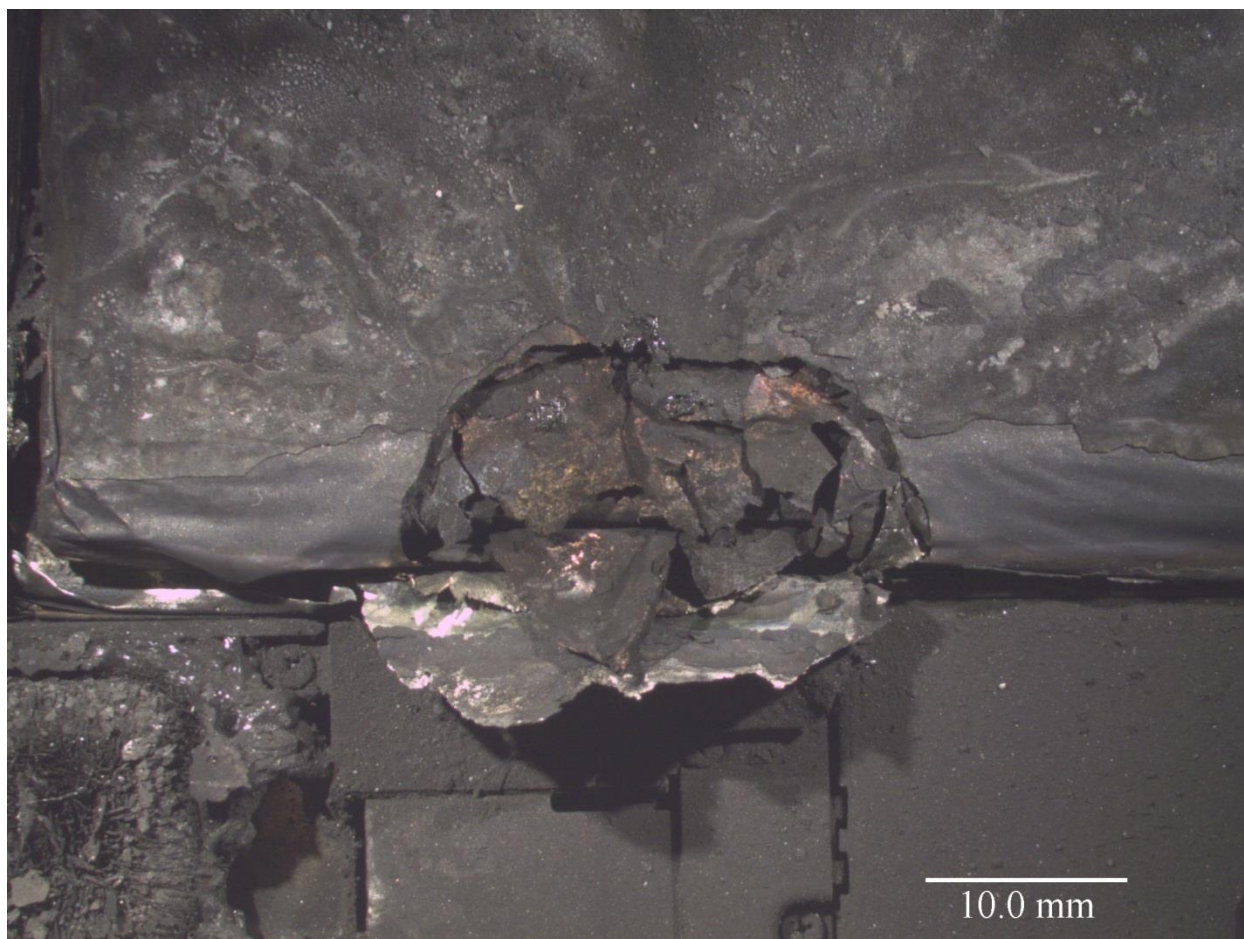
Figure 13 - Close up of battery cell rupture
